**Flood Control Project Maintenance
Levee Inspections**
LMA District Cover Sheet
Spring 2018 Levee Inspection Results

Reclamation District No. 2058 Pescadero

Spring 2018 Levee Inspection Results

| Waterway | | | Bank | Unit Miles |
|--|---|---|---|---|
| Unit No. 01 Paradise Cut | | | Left | 6.58 |

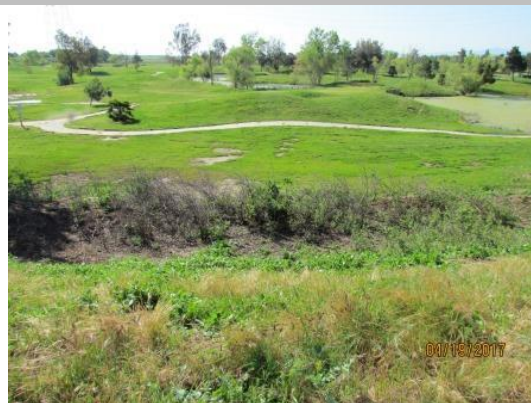
Photo 1 of 1 : SP_2018_RD2058_111_4_20180305_00005.jpg

View of the wild rose on the levee slope obstructing visibility and access.

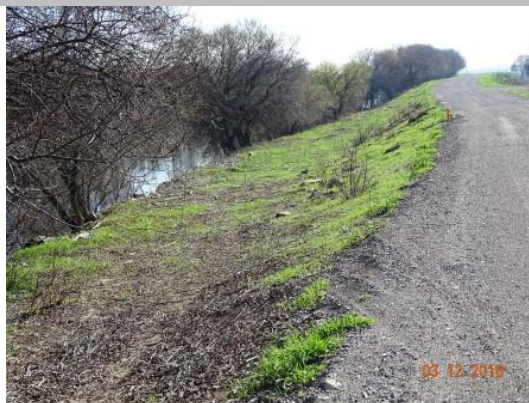
Photo 1 of 1 : SP_2018_RD2058_111_32_20180314_00064.jpg

View of the acceptable vegetation control on the levee slope.

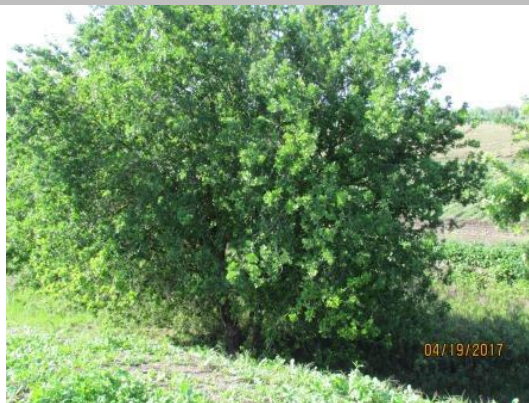
Photo 1 of 1 : SP_2018_RD2058_111_21_20180305_00013.jpg

View of the tree that needs to be trimmed.

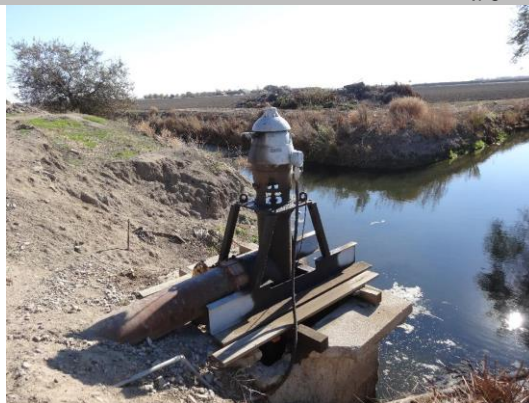
Photo 1 of 3 : UCIP_SP_2018_45843_45165.jpg

| FS_ID:45843 DS_ID:22700 EP_NO: 5055 Repair Type: Non-Urgent Crossing Status: Found UCIP Comments: Excessive oil leakage. FIELD_STRUCT_DESC: 16-inch steel drainage discharge pipe through the levee, 3.8 feet below the crown. Drainage ditch on the landside (LS). Pump on a concrete sump on the LS. Siphon breaker under protective cover on the waterside (WS) slope. (To abandon the existing 12-inch pipe with concrete and install a new 16-inch pipe authorized under Permit No. 5055, 1965 - Stanley Electric Motor Company). 12-inch pipe grouted in place. [Additional Reference(s): DWR Levee Log, 2005. USACE San Joaquin O&M Manual 10, March 1964, (HLM 0.72)]. FS Date: 5/12/2015 | | | | | | |

LS view: exposed pipe and vertical pump on concrete sump on drain ditch.

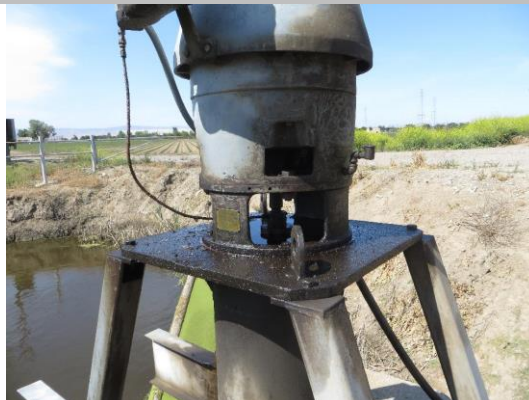
Photo 2 of 3 : UCIP_SP_2018_45843_74061.jpg

LS view: closeup of pump showing excessive oil leakage.

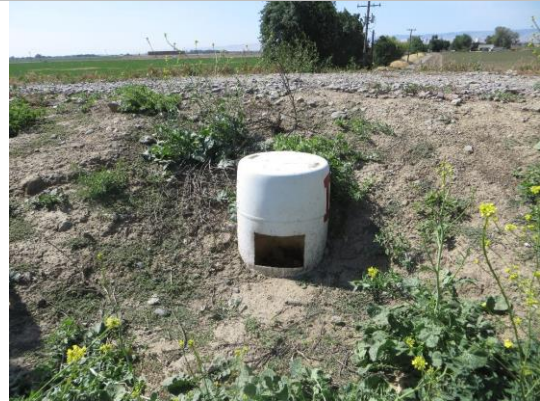
Photo 3 of 3 : UCIP_SP_2018_45843_74060.jpg

WS view: siphon breaker in protective casing.

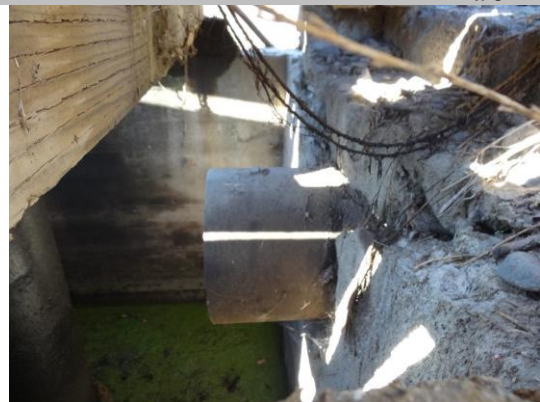
Photo 1 of 1 : UCIP_SP_2018_45143_45168.jpg

LS view: an abandoned pipe found in concrete sump.

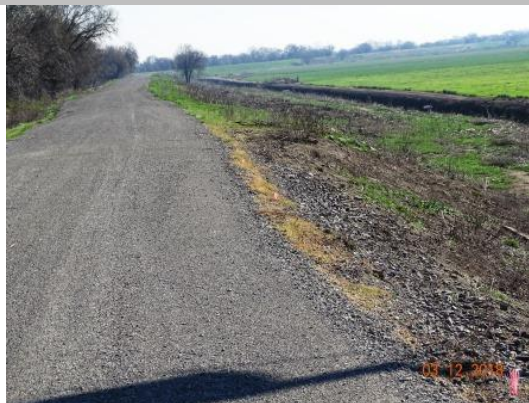
Photo 1 of 1 : SP_2018_RD2058_111_35_20180314_00065.jpg

View of the acceptable vegetation control on the levee slope.

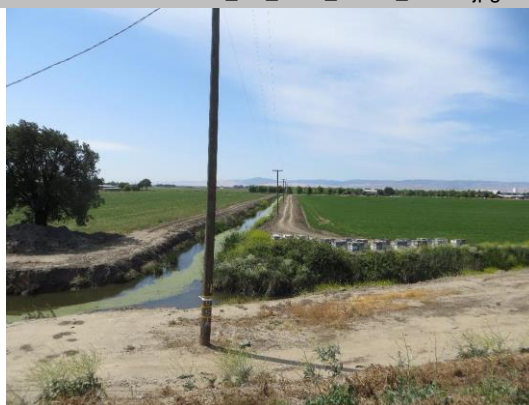
Photo 1 of 1 : UCIP_SP_2018_45847_74322.jpg

| FS_ID:45847 DS_ID:22693 EP_NO: 10426 Repair Type: Non-Urgent Crossing Status: Indicator Found UCIP Comments: Crossing needs to be marked. FIELD_STRUCT_DESC: 33-inch concrete encased steel sewer line through the levee, 17 feet below the crown. Manholes visible along Delta Avenue, but no other indicators visible at the levee. (Sewer line authorized under Permit No. 10426, 1975 - City of Tracy, care of CDM, Inc.). [Additional Reference(s): DWR Levee Log, 2005]. FS Date: 5/12/2015 | | | | | |

View of LS. Alignment of Crossing to right of canal at dirt access road.

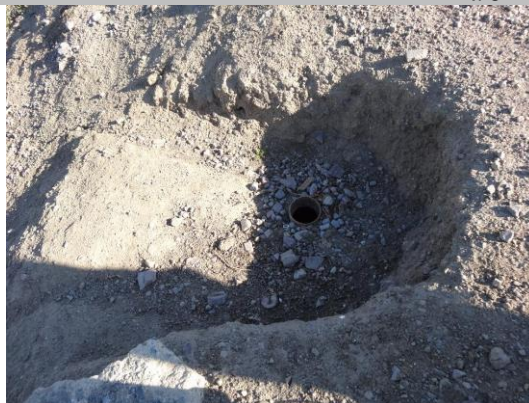
Photo 1 of 3 : UCIP_SP_2018_51161_45171.jpg

FS_ID:51161
DS_ID:22694
EP_NO: 11546
Repair Type: Urgent
Crossing Status: Found
UCIP Comments: 11/29/2016 Heavy erosion still present. Could be due to wave run-up as this is the only spot on levee not rock revetted. Greg Pombo (RD2058) indicated permits for endangered species prevent rock revetment. (K. Fazel - UCIP)05/12/2015 Erosion on west side of pipe at W/S toe. (K. Fazel - UCIP)
FIELD_STRUCT_DESC: 1 of 2: 18-inch steel drainage discharge pipe through the levee, 2 feet below the crown. Pump in drainage ditch on the landside (LS). Siphon breaker with cover on the waterside (WS) shoulder. Electrical service pole at the LS toe. (18-inch pipe and pump authorized under Permit No. 11546, 1976 - Reclamation District No. 2058). [Additional Reference(s): DWR Levee Log, 2005].
FS Date: 11/29/2016

WS view: siphon breaker hole. Siphon breaker removed for repair.

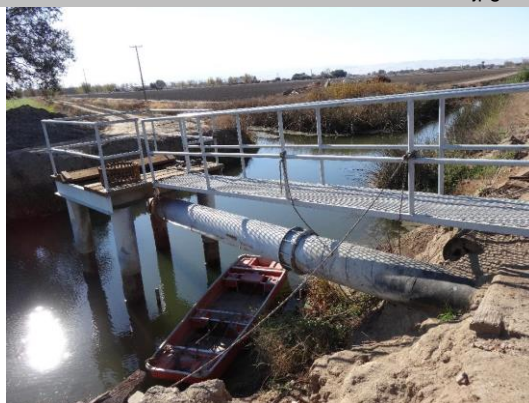
Photo 2 of 3 : UCIP_SP_2018_51161_45170.jpg

LS view: pipe, pile structure, and pump platform in drain ditch.

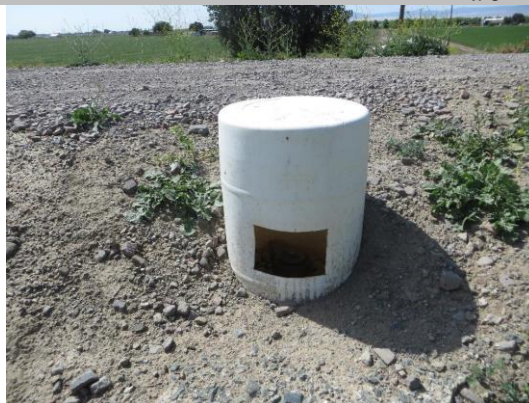
Photo 3 of 3 : UCIP_SP_2018_51161_74320.jpg

Siphon Breaker on WS shoulder.

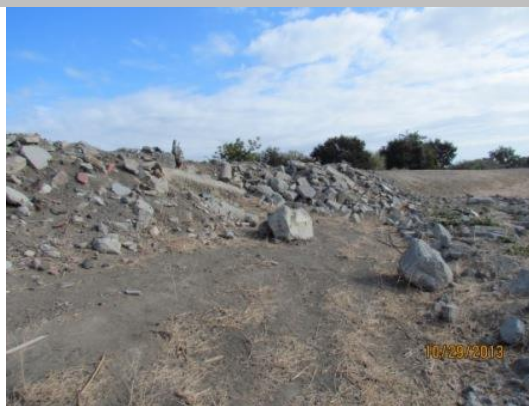
Photo 1 of 1 : SP_2018_RD2058_111_11_20180305_00006.jpg

View of the concrete with rebar placed on the landside slope.

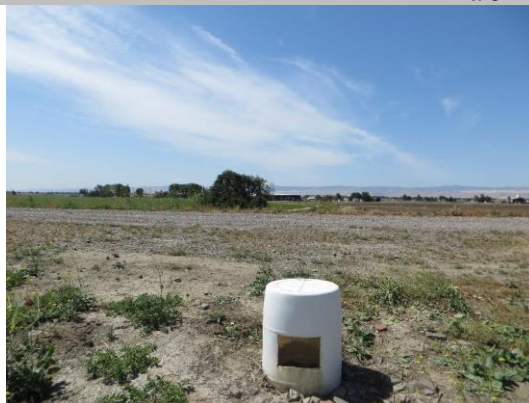
Photo 1 of 3 : UCIP_SP_2018_45865_74323.jpg

Siphon breaker on WS shoulder inside protective riser.

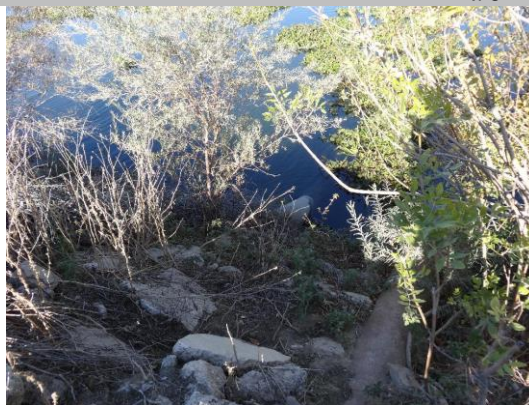
Photo 2 of 3 : UCIP_SP_2018_45865_74324.jpg

Pipe just visible at WS toe at center of photograph.

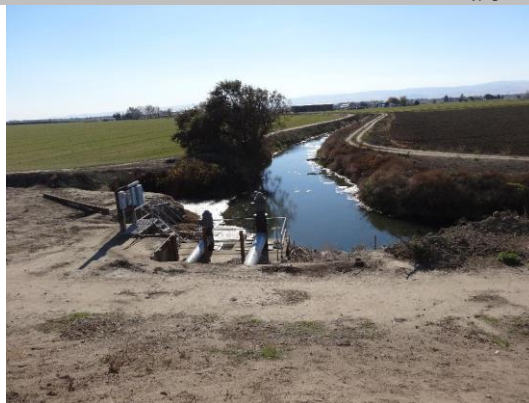
Photo 3 of 3 : UCIP_SP_2018_45865_74325.jpg

Pump on concrete pad at LS toe.

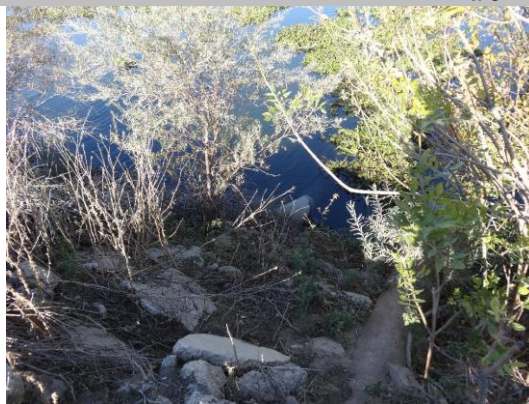
Photo 1 of 3 : UCIP_SP_2018_51699_45192.jpg

| FS_ID:51699 DS_ID:22706 EP_NO: N/A Repair Type: Non-Urgent Crossing Status: Found UCIP Comments: Leaky and damaged siphon breaker on waterside shoulder.. FIELD_STRUCT_DESC: 16-inch steel drainage discharge pipe through the levee, 8 feet below the crown. Pump on a concrete sump in a drainage ditch on the landside (LS) toe. Siphon breaker on the waterside (WS) shoulder. [Additional Reference(s): USACE San Joaquin O&M Manual 10, March 1964, (HLM 2.14), 12-inch pipe referenced]. FS Date: 5/13/2015 | | | | | | |

WS view: exposed steel pipe (right) on channel bank.

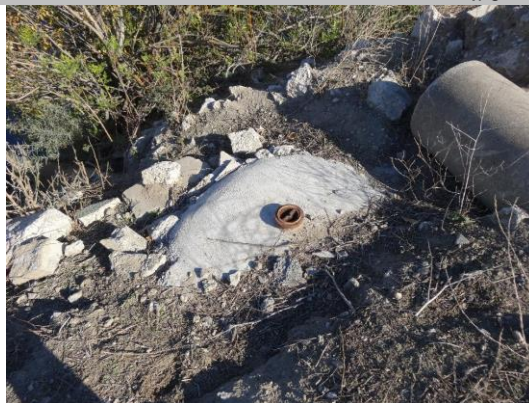
Photo 2 of 3 : UCIP_SP_2018_51699_45191.jpg

WS view: siphon breaker on concrete pad on levee slope.

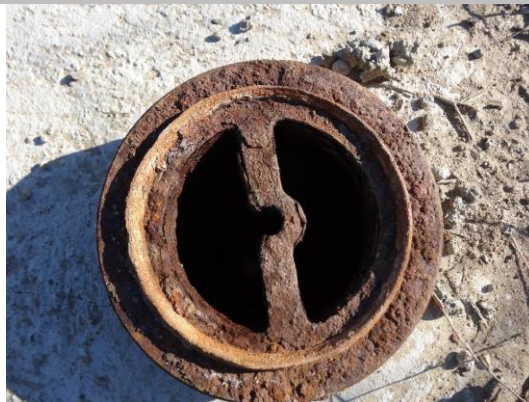
Photo 3 of 3 : UCIP_SP_2018_51699_45190.jpg

| FS_ID:51699 DS_ID:22706 EP_NO: N/A Repair Type: Non-Urgent Crossing Status: Found UCIP Comments: Leaky and damaged siphon breaker on waterside shoulder.. FIELD_STRUCT_DESC: 16-inch steel drainage discharge pipe through the levee, 8 feet below the crown. Pump on a concrete sump in a drainage ditch on the landside (LS) toe. Siphon breaker on the waterside (WS) shoulder. [Additional Reference(s): USACE San Joaquin O&M Manual 10, March 1964, (HLM 2.14), 12-inch pipe referenced]. FS Date: 5/13/2015 | | | | | | |

WS view: Upper part of the siphon breaker missing.

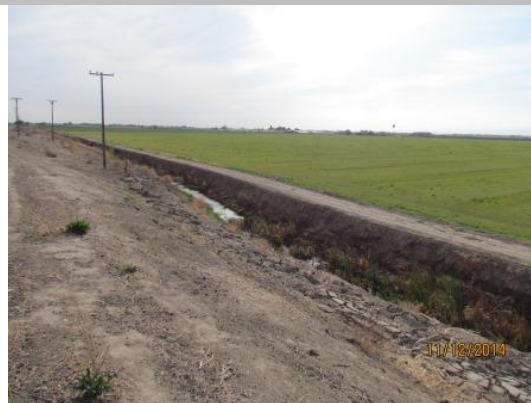
Photo 1 of 1 : SP_2018_RD2058_111_12_20180305_00007.jpg

View of the ditch at the landside levee toe.

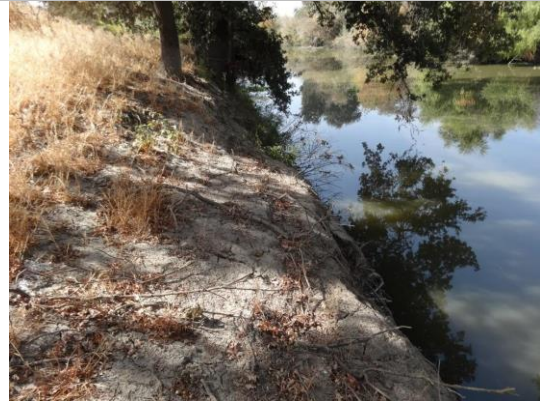
Photo 1 of 4 : SP_2018_RD2058_111_1_20180305_00001.jpg

| 07/23/2009: No major change observed since last visit; site is a 200-ft. long near-vertical berm erosion; recommend annual assessment and monitoring of the erosion site, per CLRO CES Evaluation 2008 Report; Site # is the same site previously reported as RM4.0,LM4.51; previously rated "U". | | | | | |

Direct view of the pocket erosion site.

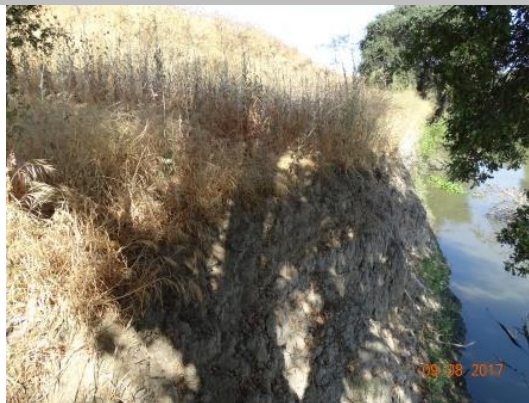
Photo 2 of 5 : SP_2018_RD2058_111_40_20180305_00031.jpg

Another downstream view of the erosion.

| E2 : Schedule repair of erosion site prior to the next inspection. | | | | | | |

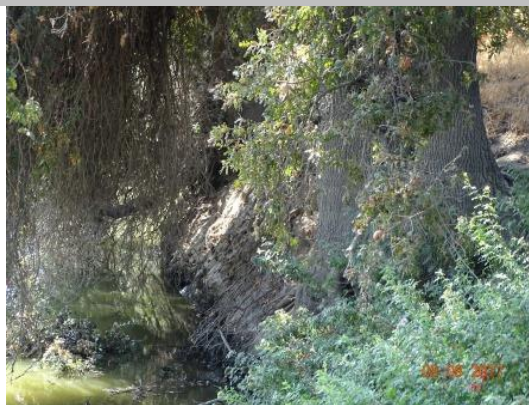
Photo 3 of 5 : SP_2018_RD2058_111_40_20180305_00032.jpg

Upstream view of the erosion site.

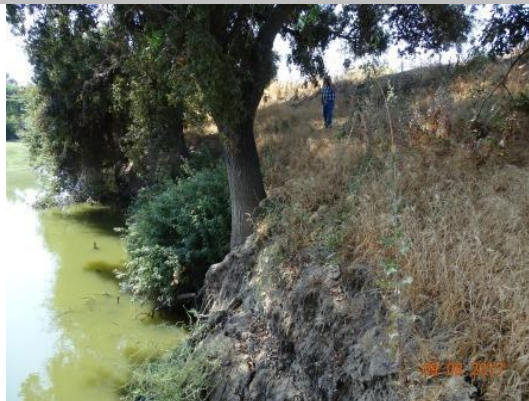
Photo 4 of 5 : SP_2018_RD2058_111_40_20180305_00033.jpg

Another upstream view of the erosion site.

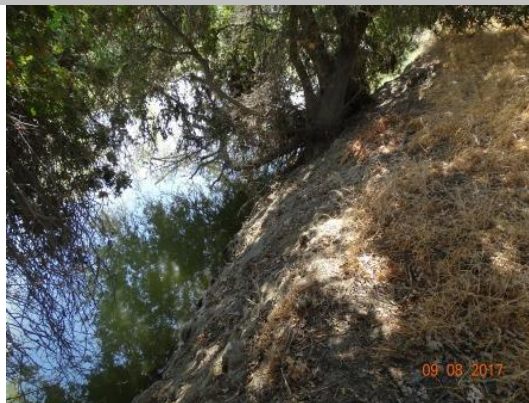
Photo 5 of 5 : SP_2018_RD2058_111_40_20180305_00034.jpg

Erosion on the bank looking upstream.

| E2 : Schedule repair of erosion site prior to the next inspection. | | | | | | |

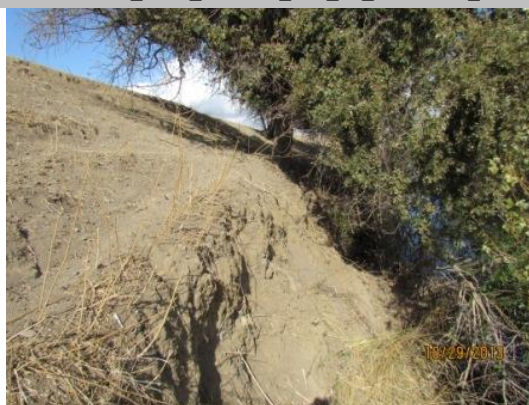
Photo 1 of 3 : SP_2018_RD2058_111_15_20180305_00008.jpg

View of the erosion at the waterside levee toe.

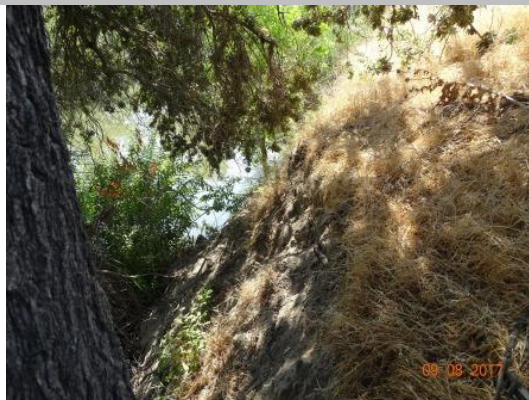
Photo 2 of 3 : SP_2018_RD2058_111_15_20180305_00009.jpg

Upstream view of the erosion.

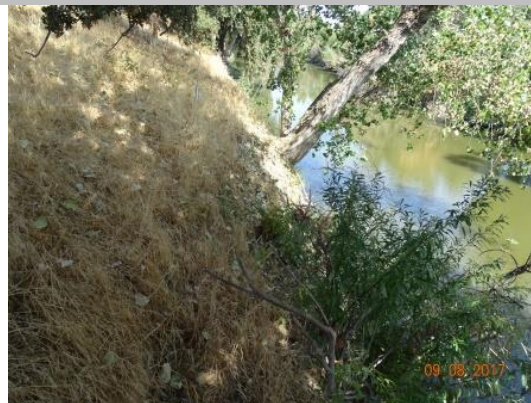
Photo 3 of 3 : SP_2018_RD2058_111_15_20180305_00010.jpg

Downstream view of the erosion site.

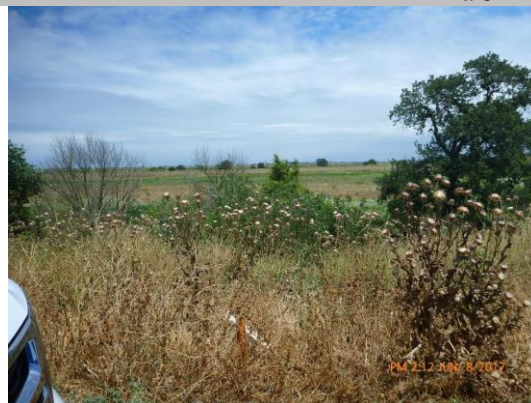
Photo 1 of 3 : LEVAL_SP_2018_100_1357.jpg

| Notes: vegetation too dense to evaluate damage. The erosion has about a 3 foot vertical cut at the waterside levee toe as of the Fall 2017 Inspection. Turned back over to Evaluators for re-assessment. | | | | | |

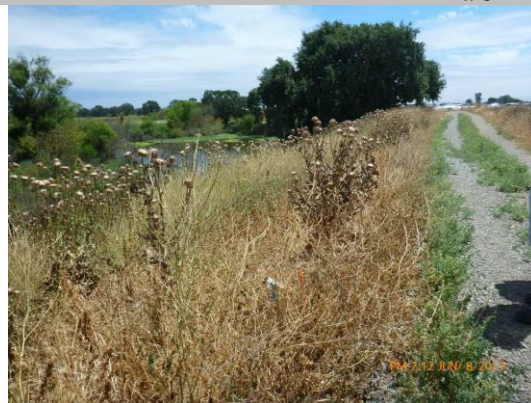
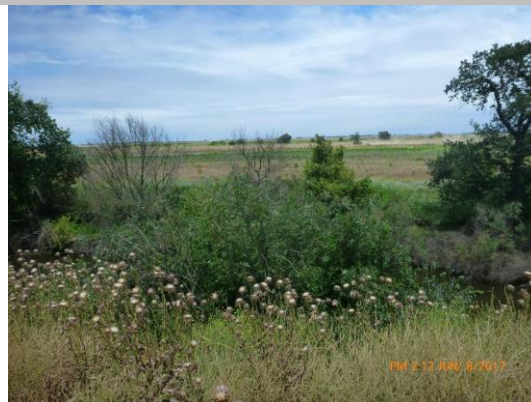
Notes: vegetation too dense to evaluate damage. The erosion has about a 3 foot vertical cut at the waterside levee toe as of the Fall 2017 Inspection. Turned back over to Evaluators for re-assessment.

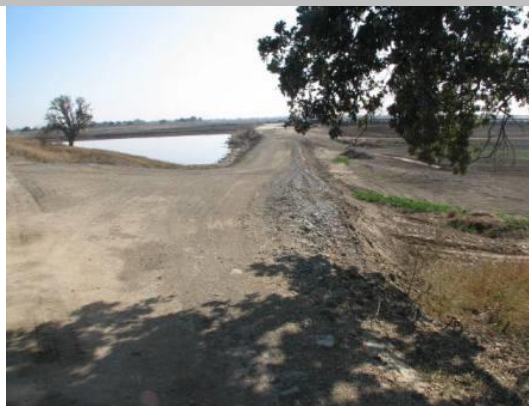
Photo 1 of 3 : SP_2018_RD2058_111_29_20180305_00017.jpg

11/08/2011 New ramp has been constructed by Dairy farmer connecting his barns to the levee.

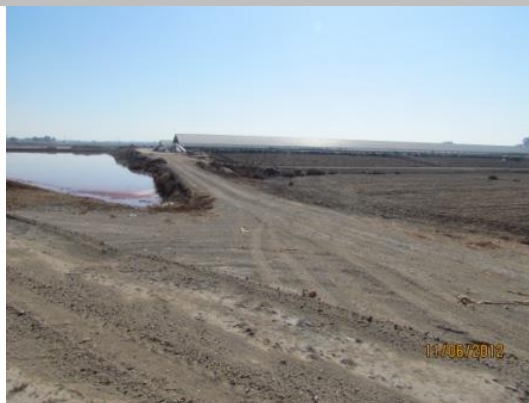
Photo 2 of 3 : SP_2018_RD2058_111_29_20180305_00018.jpg

Completed new ramp constructed by Dairy farmer connecting his barns to the levee.

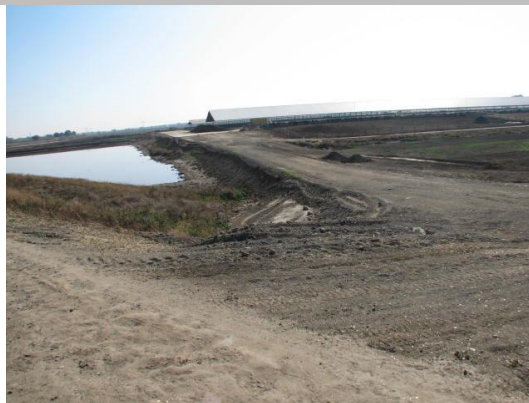
Photo 3 of 3 : SP_2018_RD2058_111_29_20180305_00019.jpg

11/08/2011 New ramp has been constructed by Dairy farmer connecting his barns to the levee.

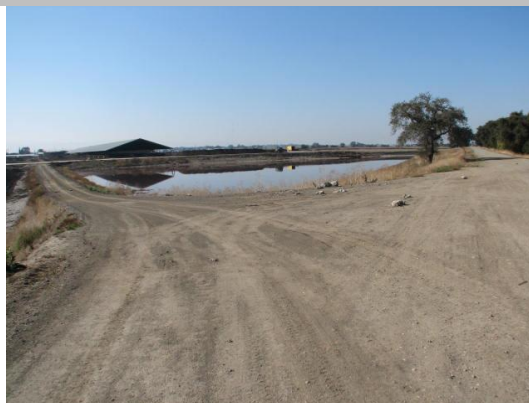
Photo 1 of 3 : SP_2018_RD2058_111_30_20180305_00020.jpg

11/08/2011 Photo shows existing middle ramp to the levee which has been raised.

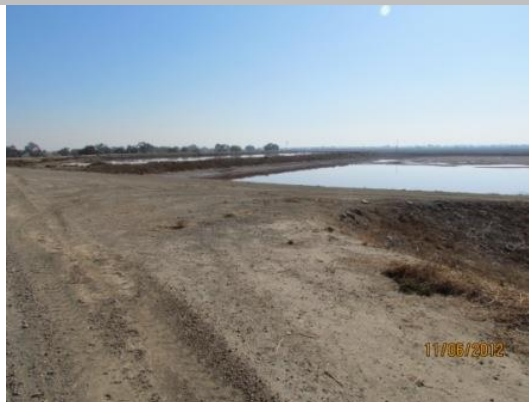
Photo 2 of 3 : SP_2018_RD2058_111_30_20180305_00021.jpg

Completed new ramp constructed by Dairy farmer connecting his barns to the levee.

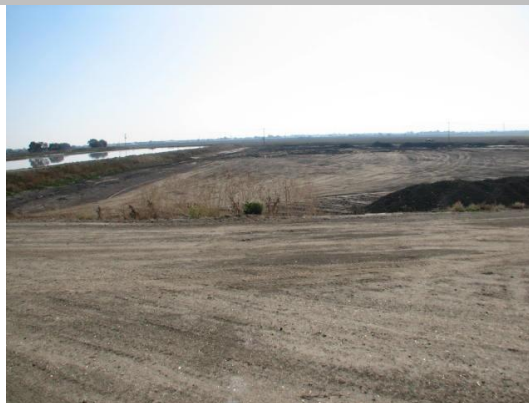
Photo 3 of 3 : SP_2018_RD2058_111_30_20180305_00022.jpg

11/08/2011 Photo shows view from the levee looking to the left of the middle ramp.

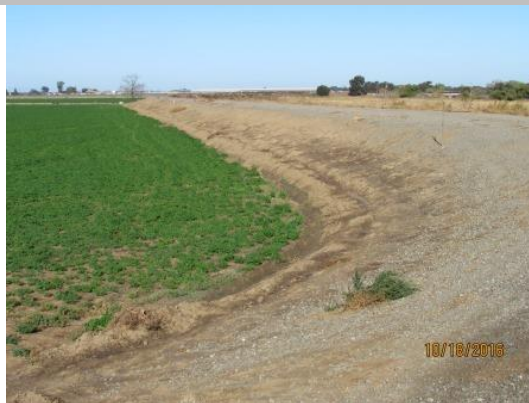
Photo 1 of 1 : SP_2018_RD2058_111_19_20180305_00011.jpg

View of the ditch at the landside levee toe.

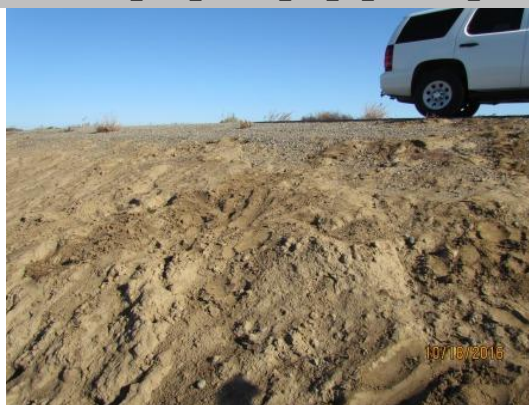
Photo 1 of 1 : SP_2018_RD2058_111_28_20180305_00016.jpg

View of the rodent holes on the levee slope.

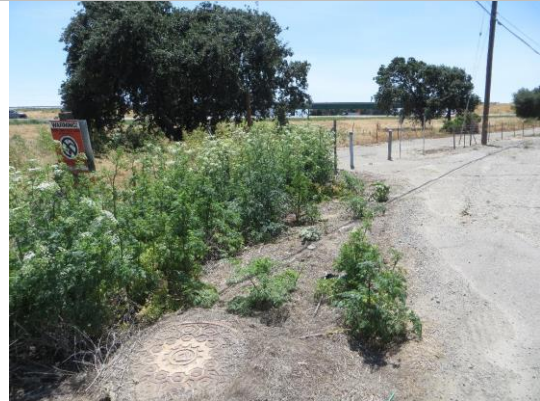
Photo 3 of 3 : UCIP_SP_2018_45871_74132.jpg

| FS_ID:45871 DS_ID:22701 EP_NO: 13262 Repair Type: Non-Urgent Crossing Status: Indicator Found UCIP Comments: Owner needs to install signs at crossing. FIELD_STRUCT_DESC: 1 of 3: 4-inch concrete encased polyvinyl chloride (PVC) electrical conduit through the levee, 3 feet below the crown. Signs on both banks of the levee. Manholes on both sides of Manthey Road. Pipes visible under Manthey Road bridge. (To install three 4-inch concrete encased PVC electrical conduits through the levee authorized under Permit No. 13262, 1981 - Pacific Telephone and Telegraph Company [PT&T]). FS Date: 5/13/2015 | | | | | | |

Comm sign and Pac Bell manhole appr. 600 ft from LS toe.

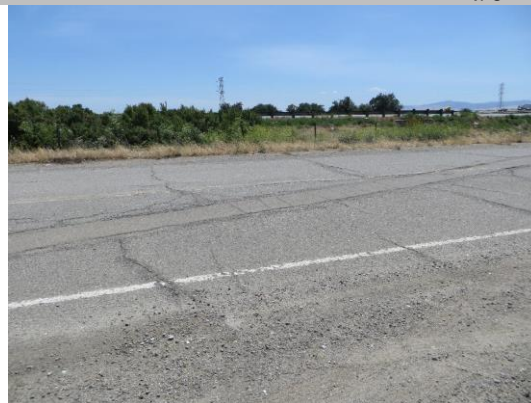
Photo 2 of 3 : UCIP_SP_2018_45768_74268.jpg

Cuts in pavement visible appr. 450 ft from WS toe.

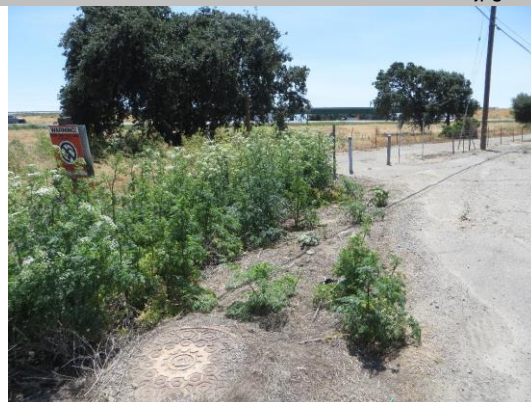
Photo 3 of 3 : UCIP_SP_2018_45768_74269.jpg

Comm sign and Pac Bell manhole appr. 600 ft from LS toe.

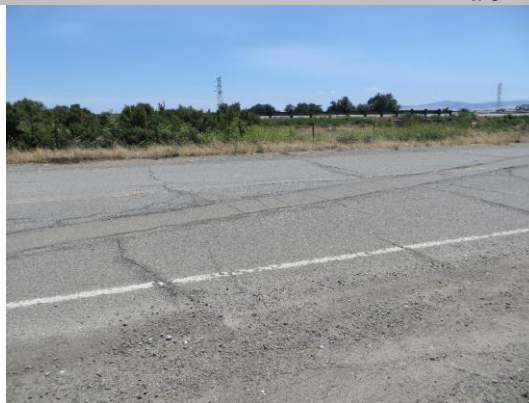
Photo 1 of 3 : UCIP_SP_2018_45769_74270.jpg

| FS_ID:45769 DS_ID:25078 EP_NO: 13262 Repair Type: Non-Urgent Crossing Status: Indicator Found UCIP Comments: Owner needs to install sign at crossing. FIELD_STRUCT_DESC: 3 of 3: 4-inch concrete encased polyvinyl chloride (PVC) electrical conduit through the levee, 3 feet below the crown. Signs on both banks of the levee. Manholes on both sides of Manthey Road. Pipes visible under Manthey Road bridge. (To install three 4-inch concrete encased PVC electrical conduits through the levee authorized under Permit No. 13262, 1981 - Pacific Telephone and Telegraph Company [PT&T]). FS Date: 5/13/2015 | | | | | |

Cuts in pavement visible appr. 450 ft from WS toe.

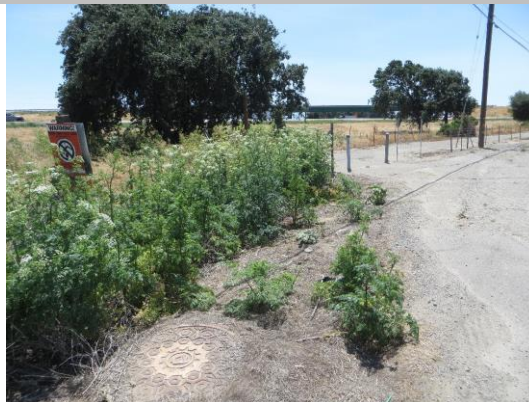
Photo 2 of 3 : UCIP_SP_2018_45769_74271.jpg

Comm sign and Pac Bell manhole appr. 600 ft from LS toe.
